HYUNDAI Technical Service Bulletin

Group	TRANSAXLE
Number	03-40-007-1
Date	MARCH, 2004
Model	1996-00 ELANTRA, 1997-01 TIBURON, 1996-04 ACCENT

Subject **ATA SOLENOID DIAGNOSTIC TROUBLE CODES - P0740, P0741, P0742, P0743, P0745, P0747, P0748, P0750, P0752, P0753, P0755, P0757, P0758, P0760, P0765**

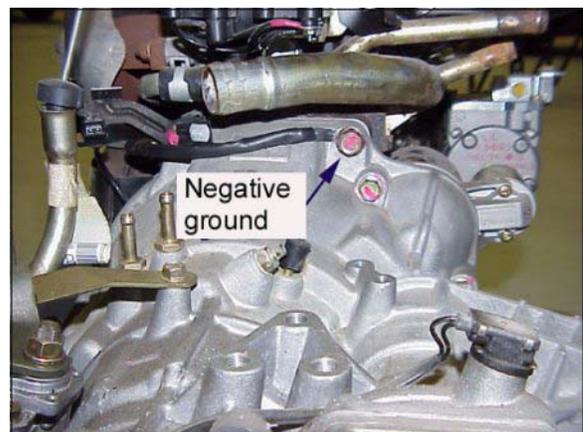
NOTE: This procedure is necessary because the solenoids ground through the transaxle case and negative battery cable.

NOTE: A high resistance ground usually causes two or more DCCSV or PCSV DTC (P0742, P0743, P0745, P0747, P0748 or P0765).

1. Using a Hi-Scan Pro, check for codes in the “Automatic Transaxle” and “Engine” menus. **Record the DTC and description.**
2. Clean the connection between the battery cables and the battery posts.
3. Clean the connection between the negative battery cable and the transaxle case. Reinstall the cable.

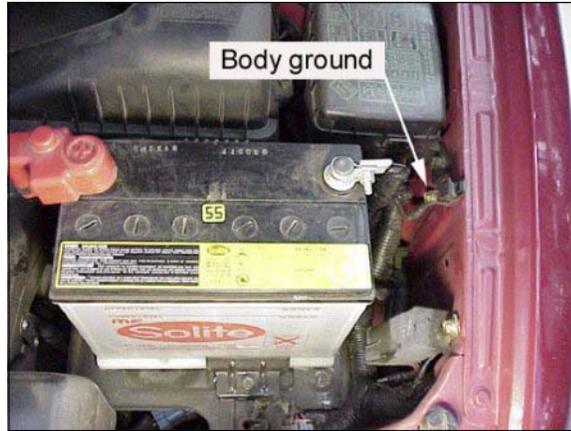
NOTE: This procedure is necessary because the TCM grounds through the body ground.

4. Clean the connection between the negative battery cable and the body ground bolt located next to the battery. Apply conductive grease to the connection before reinstalling the bolt.
